River's End Staging Area (RESA)

15 1st Street, Seal Beach, Orange County

Permit/LCP #: 5-10-220

Site Visit: Staff: Tamara Doan Date: May 10, 2012

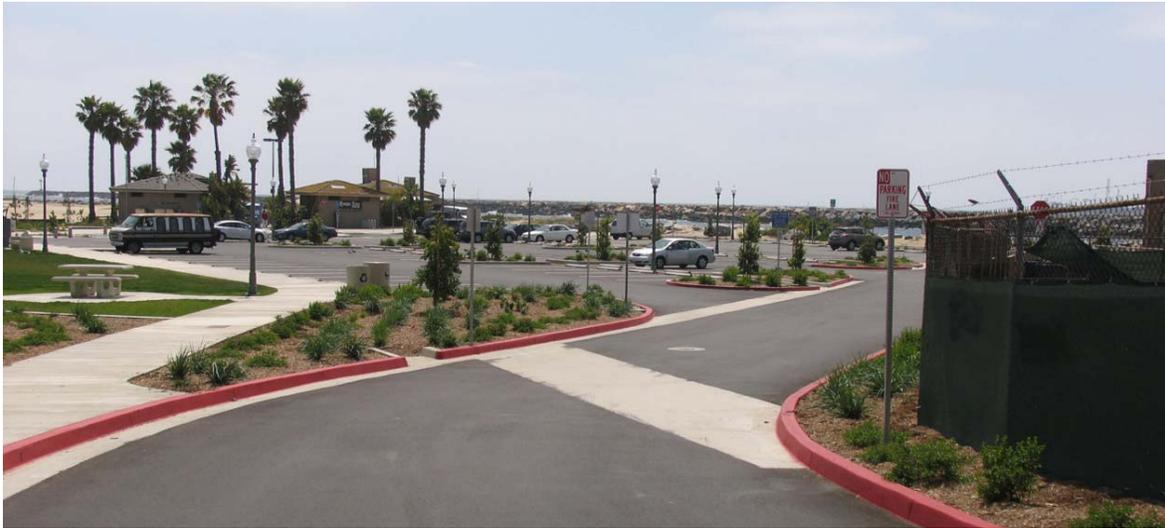
Photo 1.

The newly redesigned parking lot at the RESA site provides vegetated bioswale areas for the infiltration of surface runoff. This view shows the entry driveway in the foreground, the parking lot, and the River's End Café structure at the rear of the lot. In many cases the curbs guide flows to inlets that direct any surface water flows to the bioswale infiltration areas.

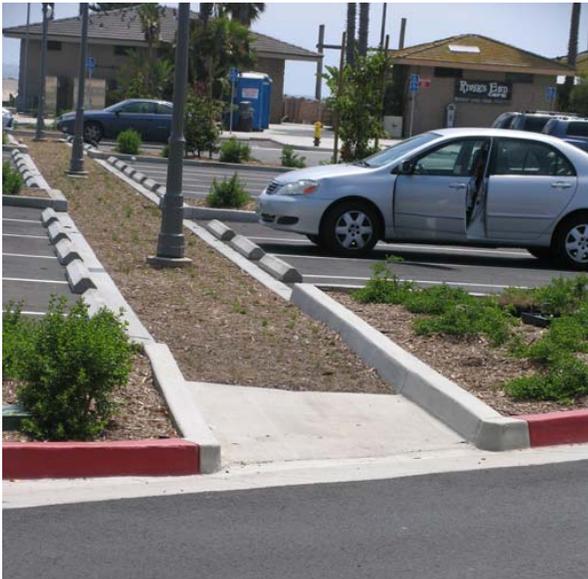
Photo 2.

Any surface runoff from the driveway or areas under parked cars is directed through concrete channels to the vegetated areas for infiltration. In this view of one of the center bioswales, there is approximately 2" of mulch placed on top of 2" of grass-seeded soil, on top of the underlying sand.

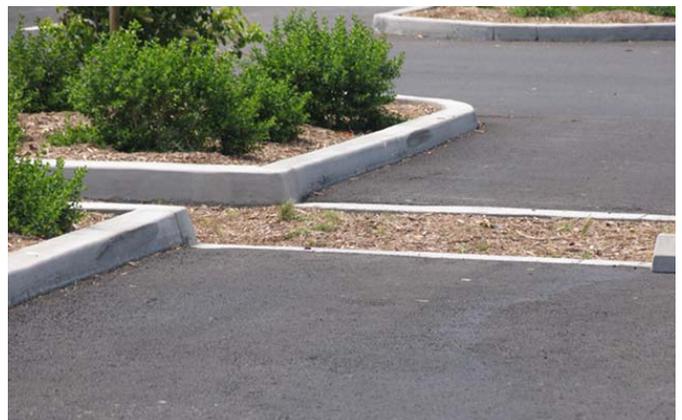
Photo 3.

The parking lot rows are graded such that any surface water leaving parking rows flows to one of the center bioswales. Early signs of native grass can be seen on the left of the mulched areas. "End cap" planting areas for shrubs and trees are completely curbed and irrigated so that deeper soil profiles can be maintained for those larger plants.

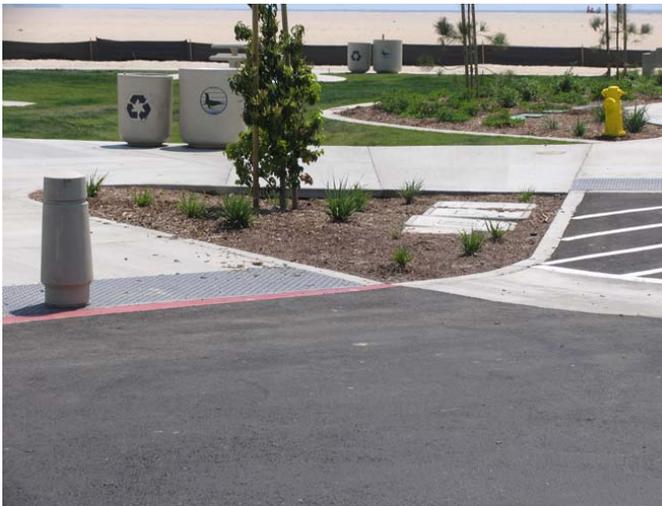
Photo 4.
The far areas of the parking lot are all graded to flow onto vegetated bioswale areas for infiltration.

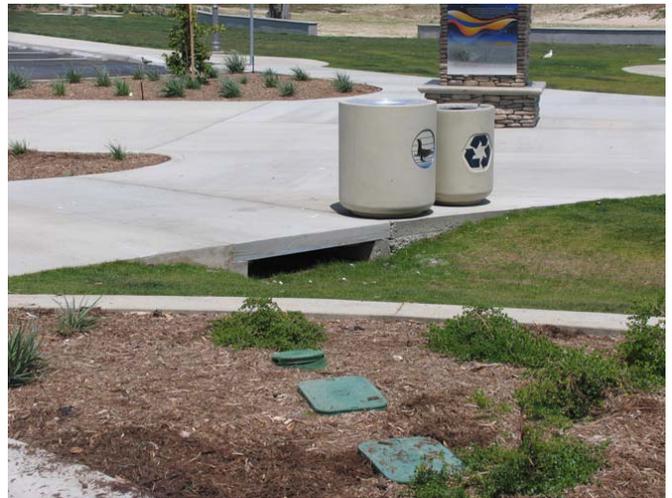
| BMP # | Description | Observations * | Grade */ Follow Up |
|---|--|---|---|
| 2 | Trash containers designed to prevent scavenging and wind blown distribution. | Trash and Recycling containers installed in the redesigned parking and recreation areas were covered by incorporated aluminum covers. However, all the beach trash receptacles were plastic drums with no lids, and trash was observed in the beach areas [Photo 4-5]. | B |

Photo 5.
Any surface flows from the side walk flow to the grassed infiltration areas and allow for overflows to other areas. All Trash and Recycling containers at the site have lids to limit the amount of scavaging by birds or blow out by winds.

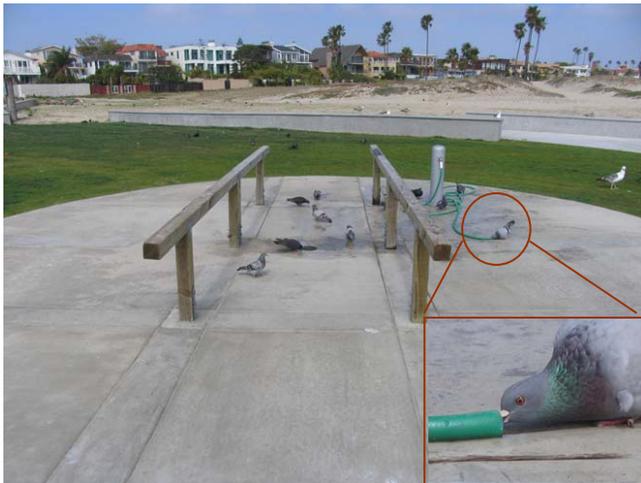
Photo 6.
A windsurfing rigging station was installed with a hose for board wash down. This area is used by both windsurfers and surfers. As well, local birds find the freshwater a great resource.

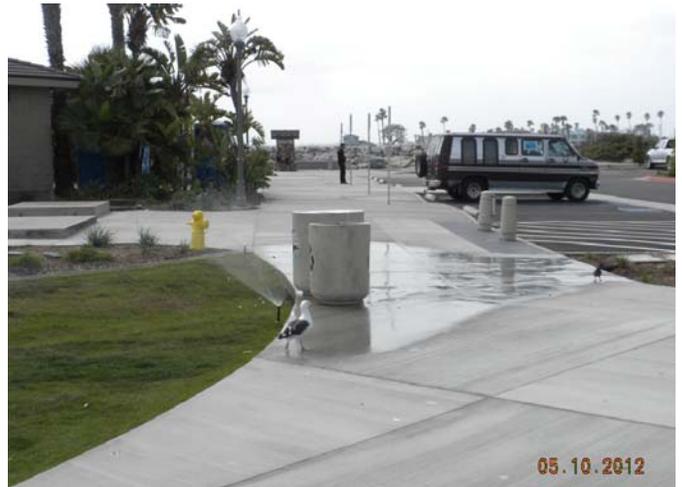
A few issues with this watering regime in practice were observed: 1) this was the windiest part of the afternoon (hence the increased afternoon use of the location by windsurfers) and water seemed to overspray all of the sidewalk areas, creating excessive runoff; 2) so much water was deployed that there was standing water in the grass at the site after the rotation had moved to another sector; and 3) no irrigation was observed for the vegetation in the infiltration strips between the parking rows in the parking lot (where the vegetation was not seen to be successful).

Photo 7.
During the irrigation event observed, overspray water was blown onto the sidewalk areas and drained back into another of the vegetated areas adjacent to the parking lot.

Recommend Follow up? Yes, moderate priority; to assure irrigation issues are resolved.

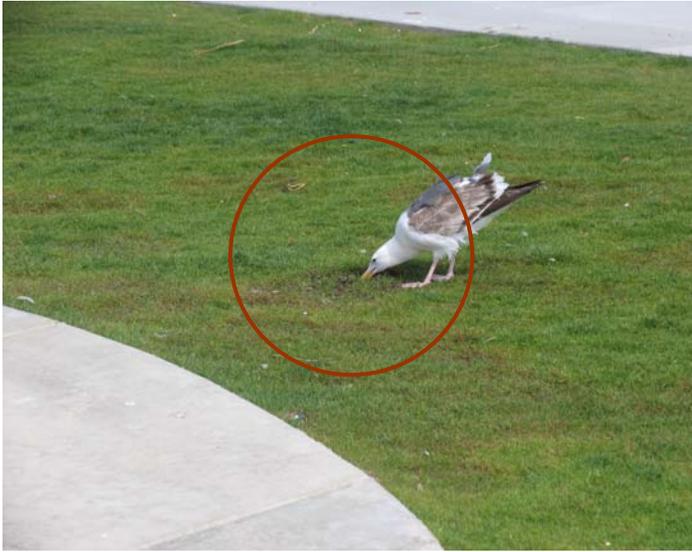
Photo 8.

Additionally, it was noted by the City's representative during the first part of the visit that the birds (pigeons and gulls primarily) that visited the site were damaging the grassed areas. It was observed by staff that water did not percolate/infiltrate into the grassed areas adequately; either during the board wash-down activities of visitors, or during the irrigation event. And that once enough water built up in the grass (reached saturation) then the birds would dig 'drinking pits' in the grass, where a freshwater supply was guaranteed [Photo 8-9]. The fact that this could occur was a sign that the design or operation of the 'infiltration' aspect of these areas should be reviewed. If the grass was placed on the sand with minimal soils to provide for root development to support the lawn, then one would expect excess water to infiltrate into the sand quickly, and not allow for the saturated conditions observed. It is recommended that these conditions be followed up with the land manager to resolve the quality of infiltration occurring at the site.

After both board wash downs by recreational users and an irrigation event the grass 'park' area became saturated and the birds dug 'drinking pits' to access the fresh water.

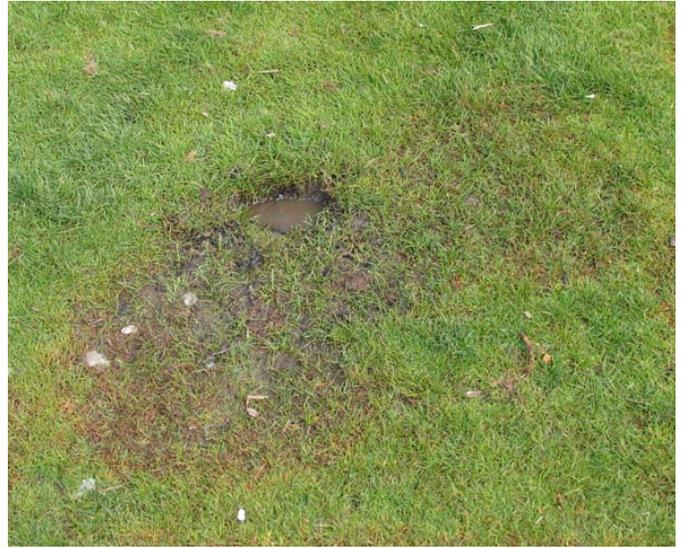
Photo 9.

This view shows the fact that the grass is saturated and there is standing water in the holes dug by the birds. This condition indicates that the grass area is not infiltrating all the water that it receives during a no storm event day.
